# Case History

# Bay Area UNDERPINNING

Twelve ECP Steel Piers™

Recovered Three Inches of Lost Floor Elevation

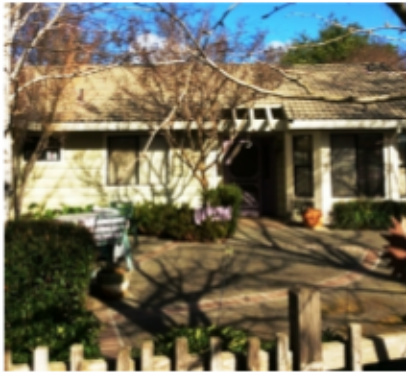
ECP PPB 300-UF Steel Piers™ were installed at each location shown on the plan. Because this steel pier product offers rapid installation and the pier placements required only a small, hand dug excavation; there was minimal intrusion on the property and the owner's normal activities were not greatly impacted.

Earth Contact Products' steel piers stabilized and raised this residence up to three inches. Twelve ECP foundation brackets were mounted under the footings and twelve ECP Steel Piers™ were driven 44 feet deep, on average, to firm bearing. Each pier was field tested to a load between 22,500 and 23,750 pounds to confirm suitable firm bearing. Each steel pier is now supporting 12,360 pounds, which is the working load required to recover lost elevation and provide long term support.

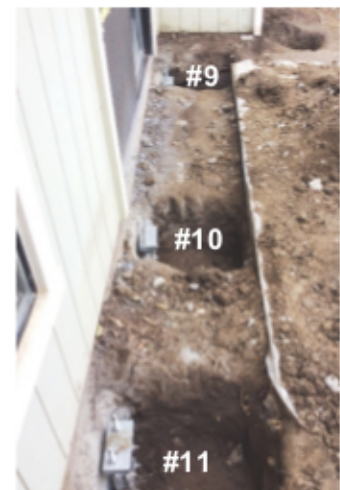
Piers #9, #10 and #11 are seen here installed and supporting the structure.
